Debris/Ice/TPS Assessment And Photographic Analysis For Shuttle Mission STS-31R

Charles G. Stevenson
NASA/Kennedy Space Center

DEBRIS/ICE/TPS ASSESSMENT
AND
PHOTOGRAPHIC ANALYSIS
OF
SHUTTLE MISSION STS-31R

April 24, 1990

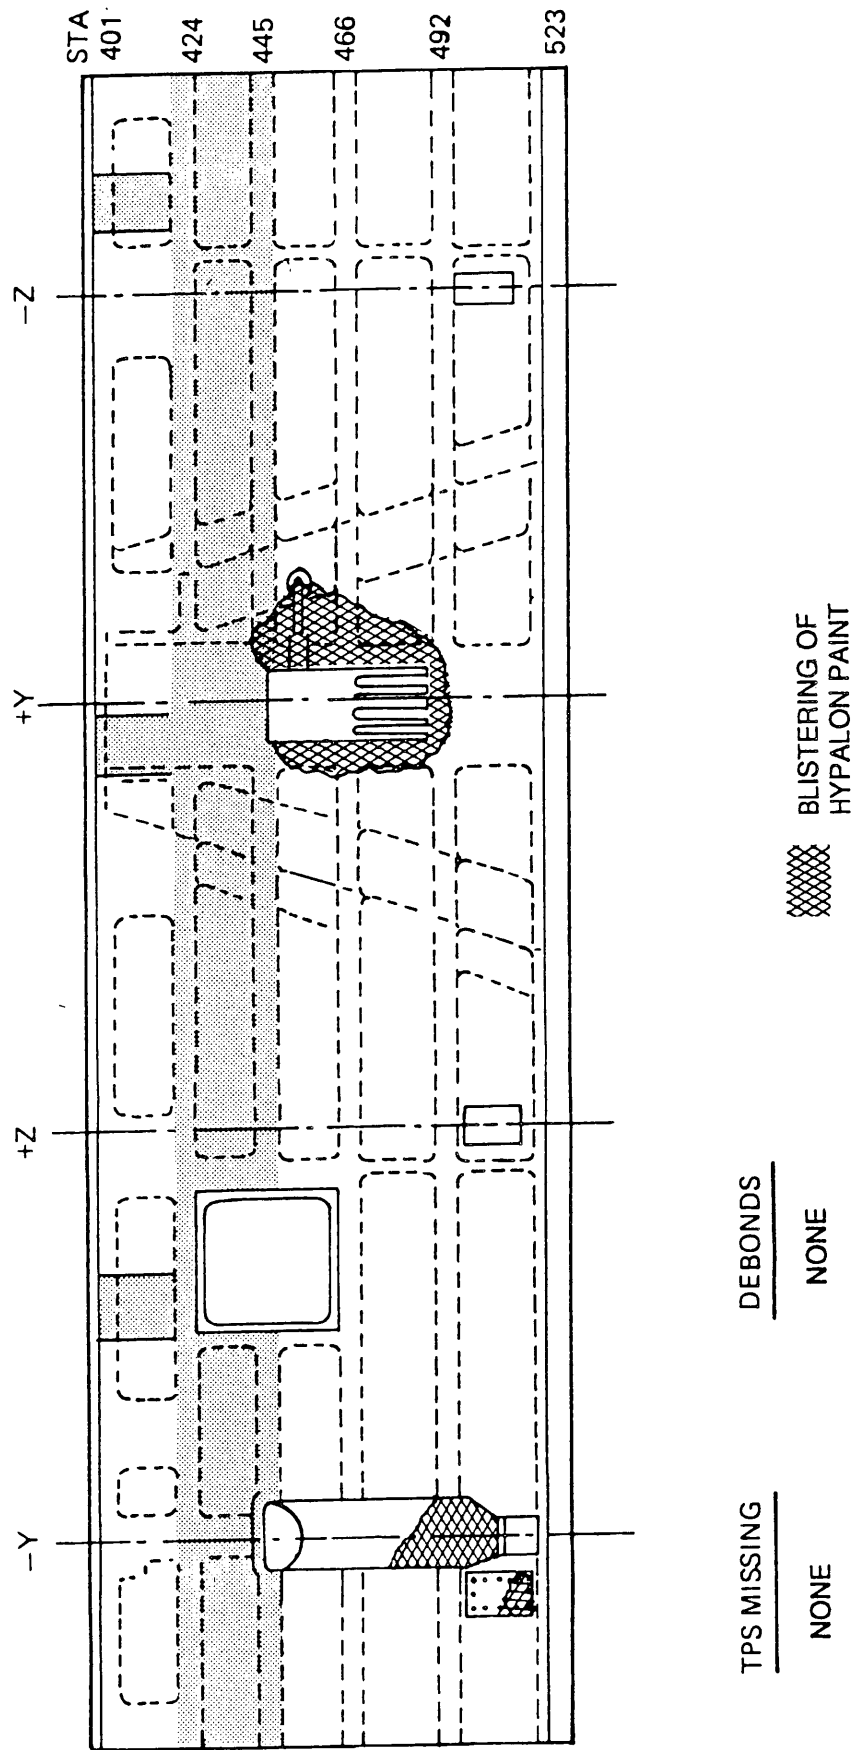
FIGURE 15. LEFT SRB FWD SKIRT

The LH forward skirt exhibited no missing TPS or debonds. Localized areas of Hypalon paint blistered with layers of MSA-2 attached to the paint (Figure 15). Separation of the forward attach bolt was nominal and the RSS cables separated cleanly. The K5NA closeouts on the inboard corners of the RSS interface cable tray were intact.

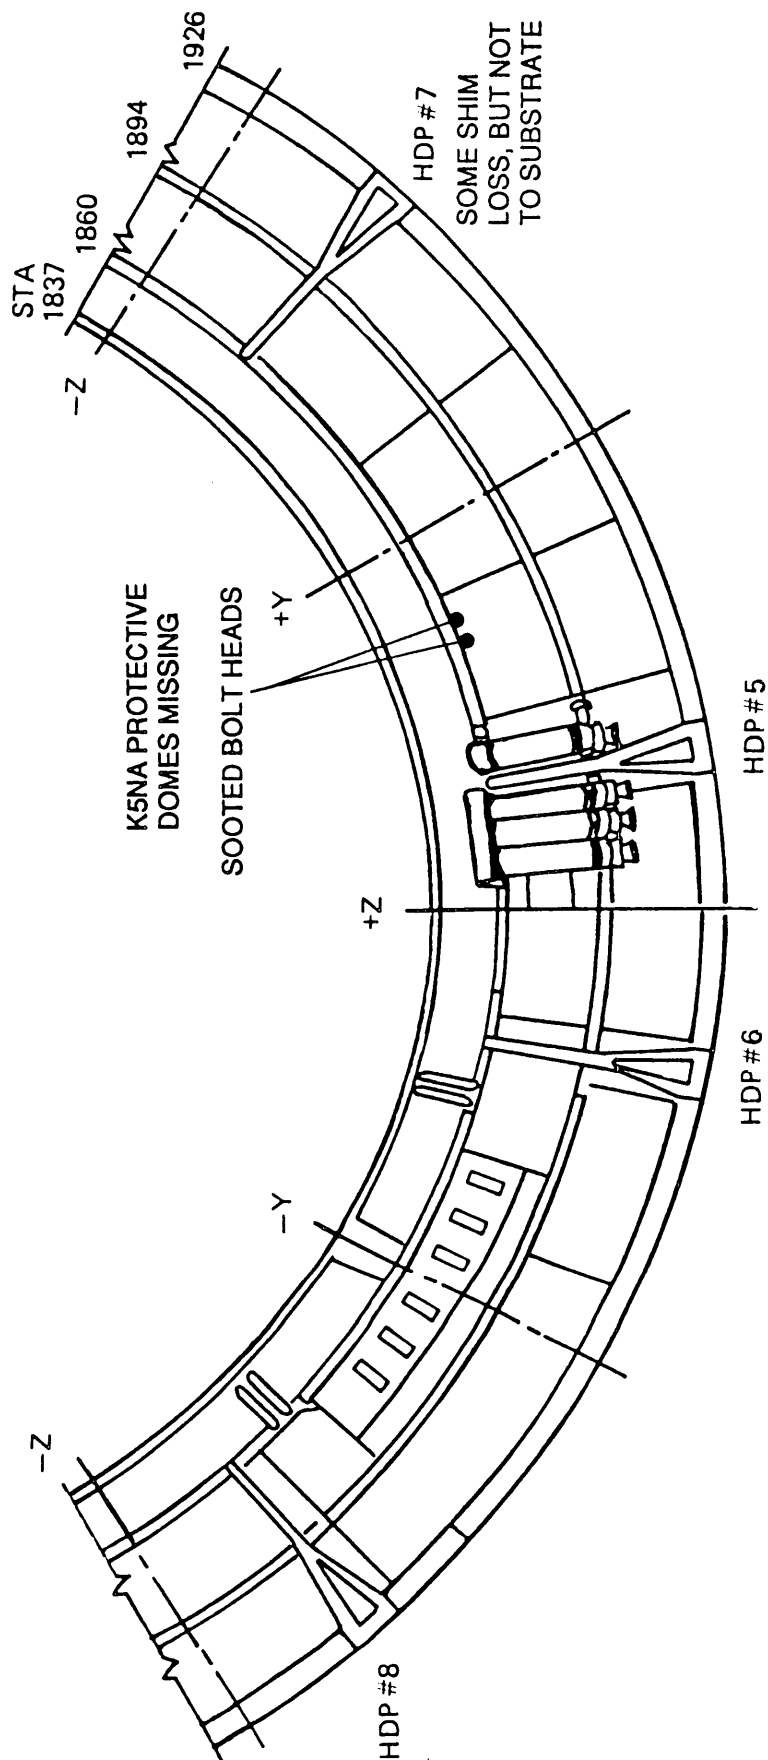
FIGURE 16. LEFT SRB AFT SKIRT EXTERIOR TPS

The TPS over the aft skirt acreage was generally in good condition (Figure 16). The phenolic material on the kick ring delaminated in several locations. Two K5NA protective domes were missing from bolt heads on the aft side of the kick ring with sooted substrate. K5NA was missing from all four BSM nozzles. The TVC system appeared to be undamaged. Instafoam was missing from the aft ring around the skirt feet, HPU exhaust horns, and the SRB T-0 umbilical.

All four DCS plungers were seated and latched. HDP #7 Epon shim exhibited some material loss, but not to substrate.

1) ALL FOUR DCS PLUNGERS WERE SEATED

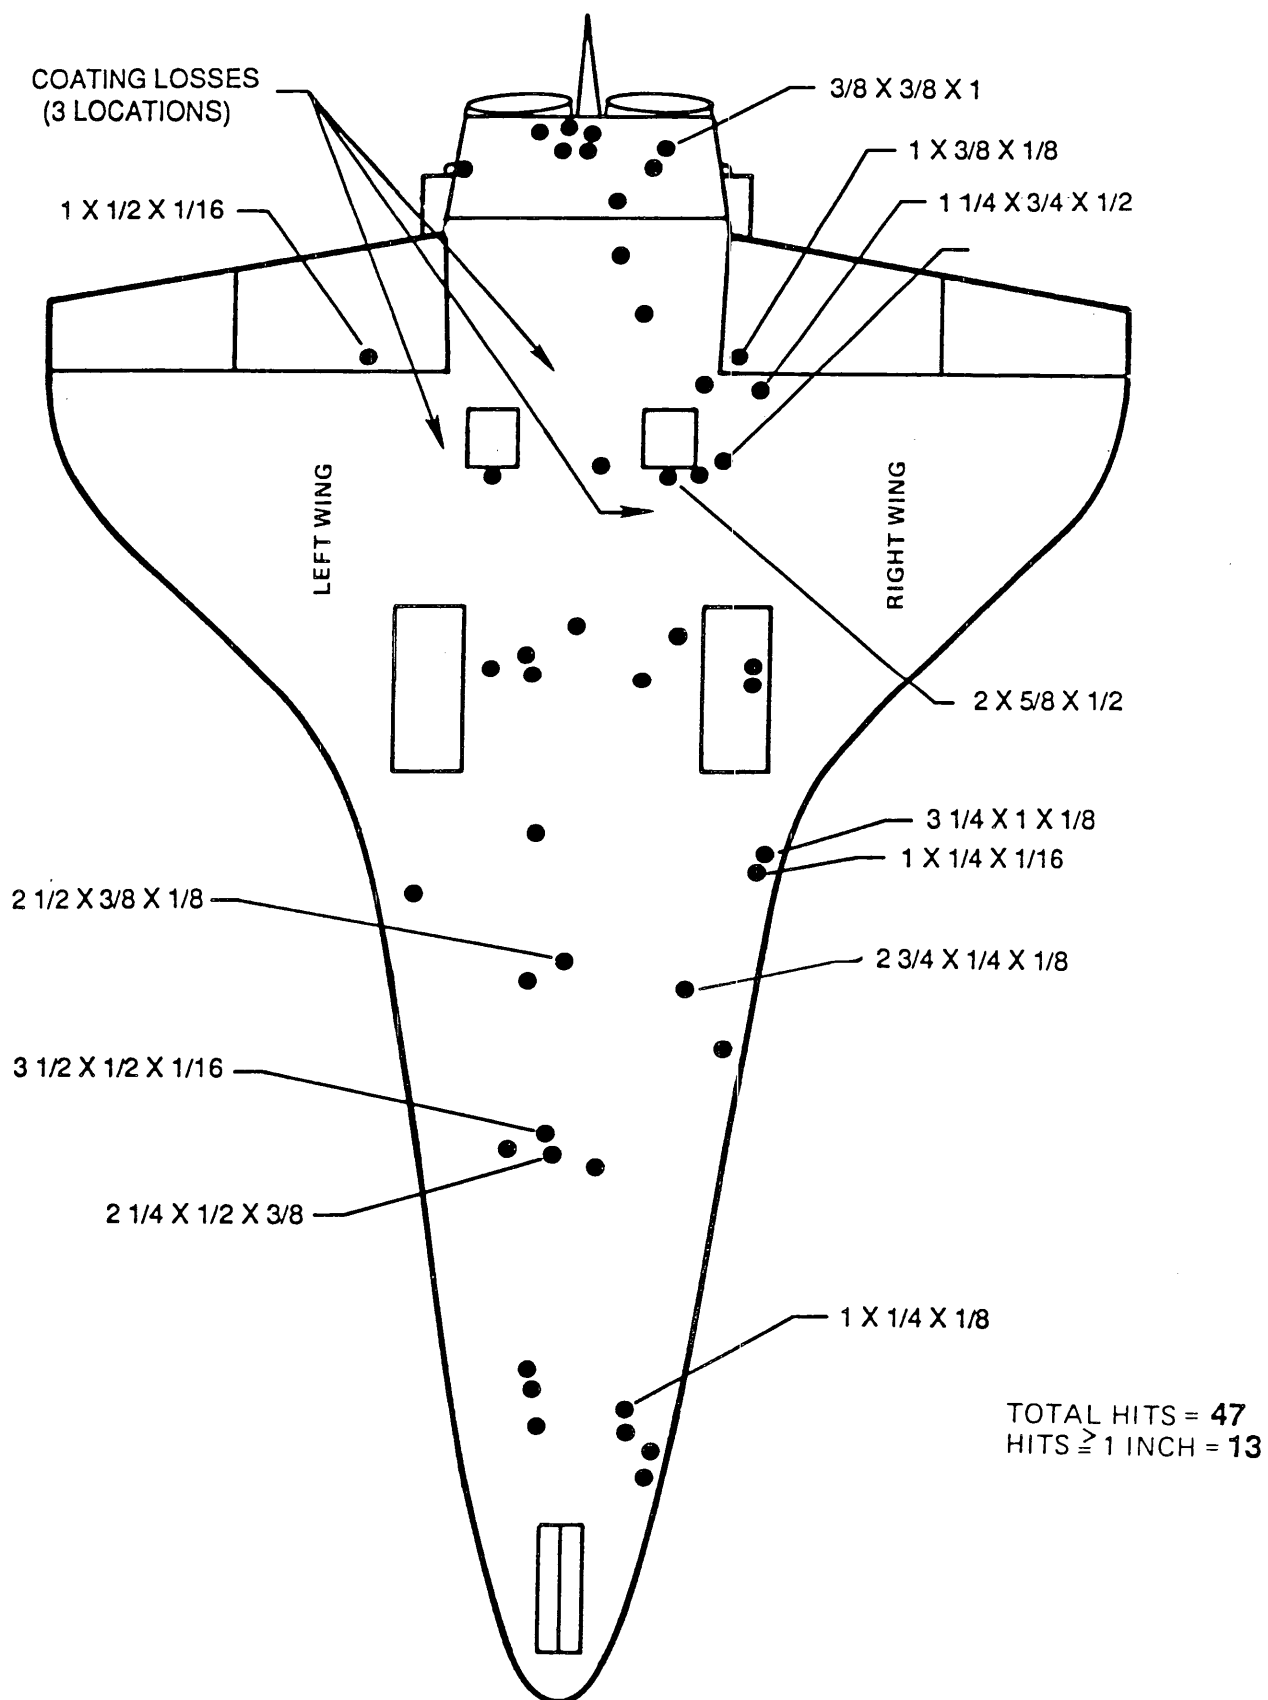
FIGURE 17. DEBRIS DAMAGE LOCATIONS

The Orbiter lower surface had a total of 47 hits of which 13 had a major dimension of one inch or greater. A comparison of these numbers to statistics from 21 previous missions of similar configuration (excluding missions STS-24, 25, 26, 26R, 27R, and 30 which had damage from known debris sources), indicates the total number of hits on the lower surface less than average. Figures 17 - 20 show the TPS debris damage assessment for STS-31R.

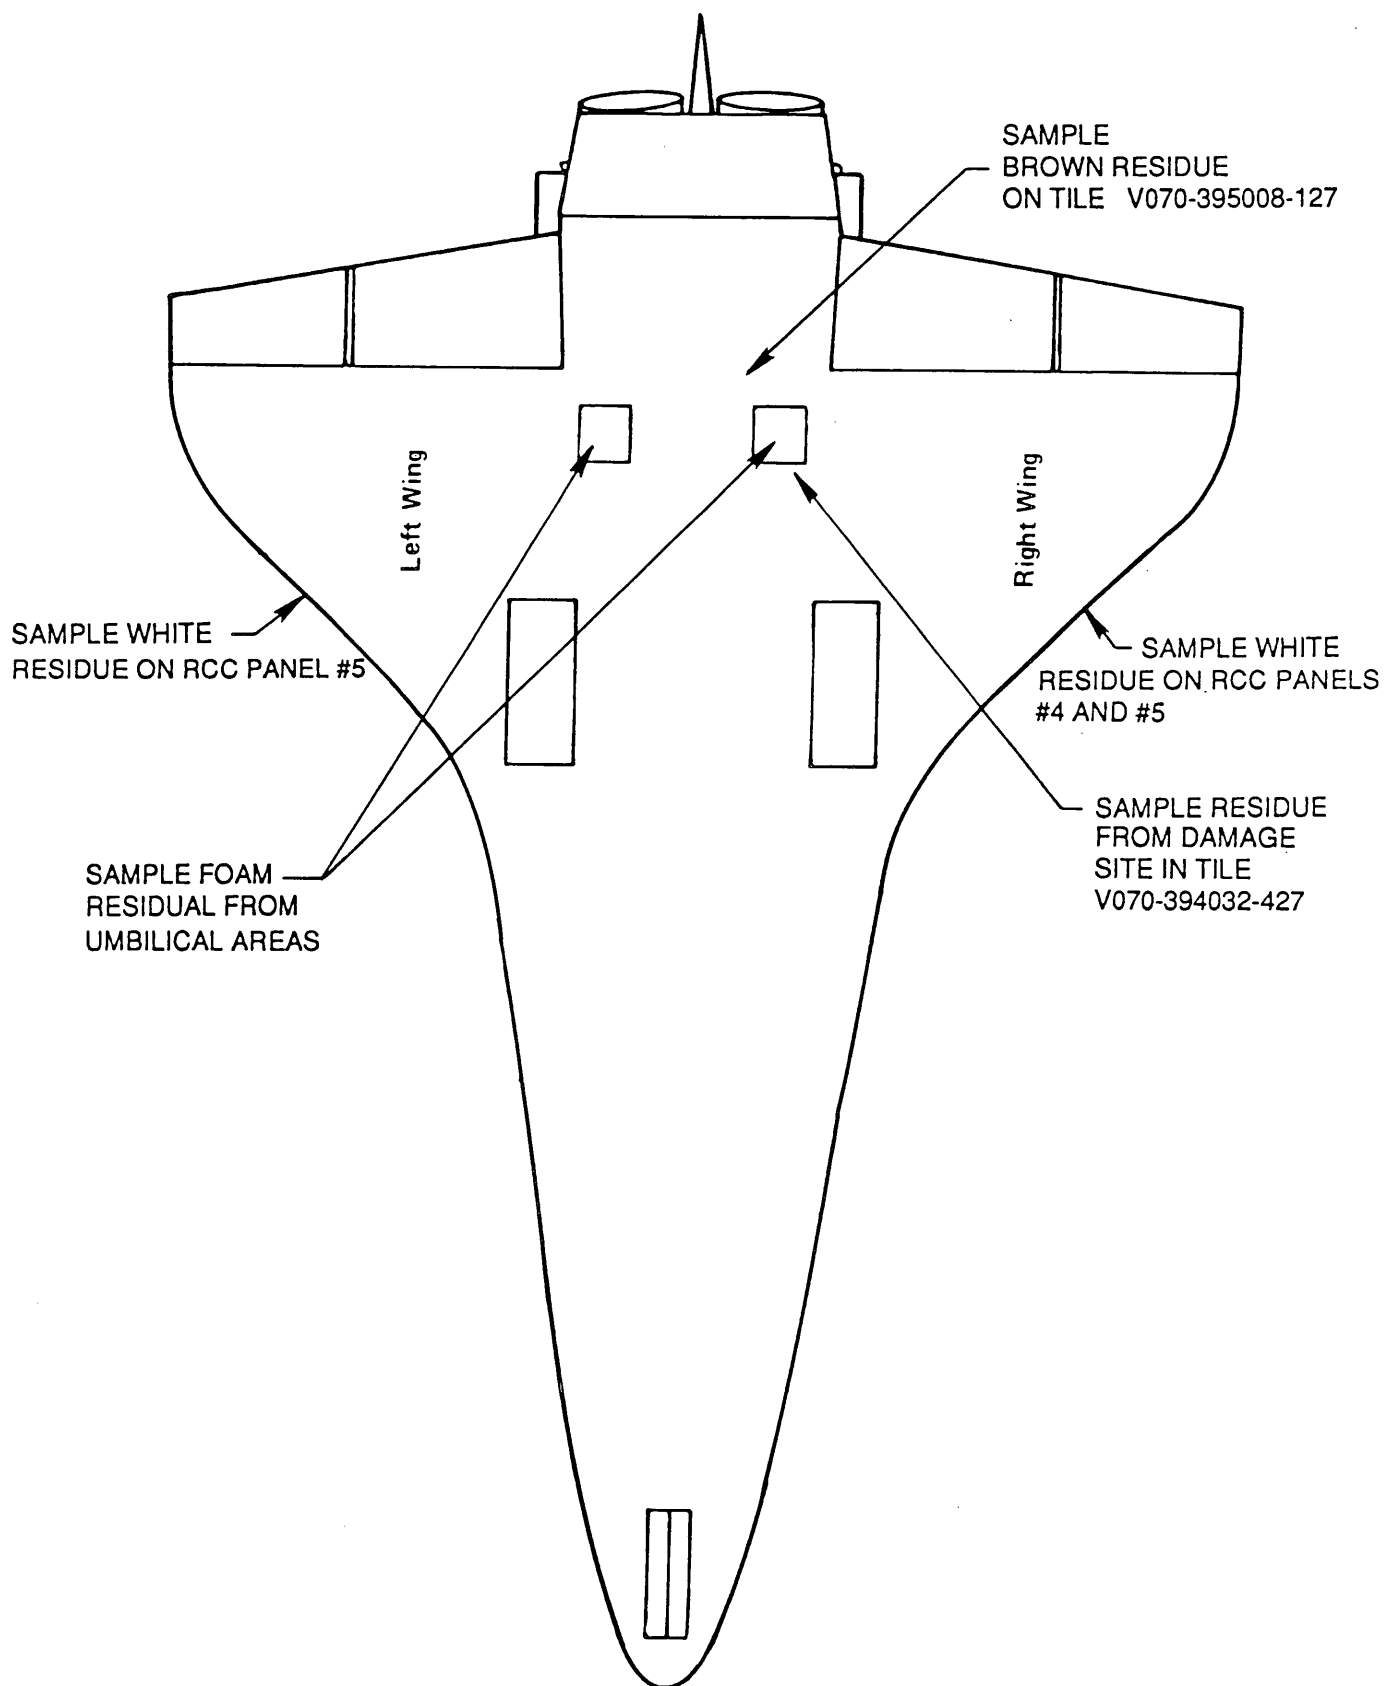
FIGURE 21. DEBRIS DAMAGE CHEMICAL SAMPLE LOCATIONS

Once the Orbiter arrived in the MDD, samples were taken from selected damage sites (Figures 21 and 22) for laboratory analysis. The results of all debris sample chemical analyses are presented in Section 10.0.

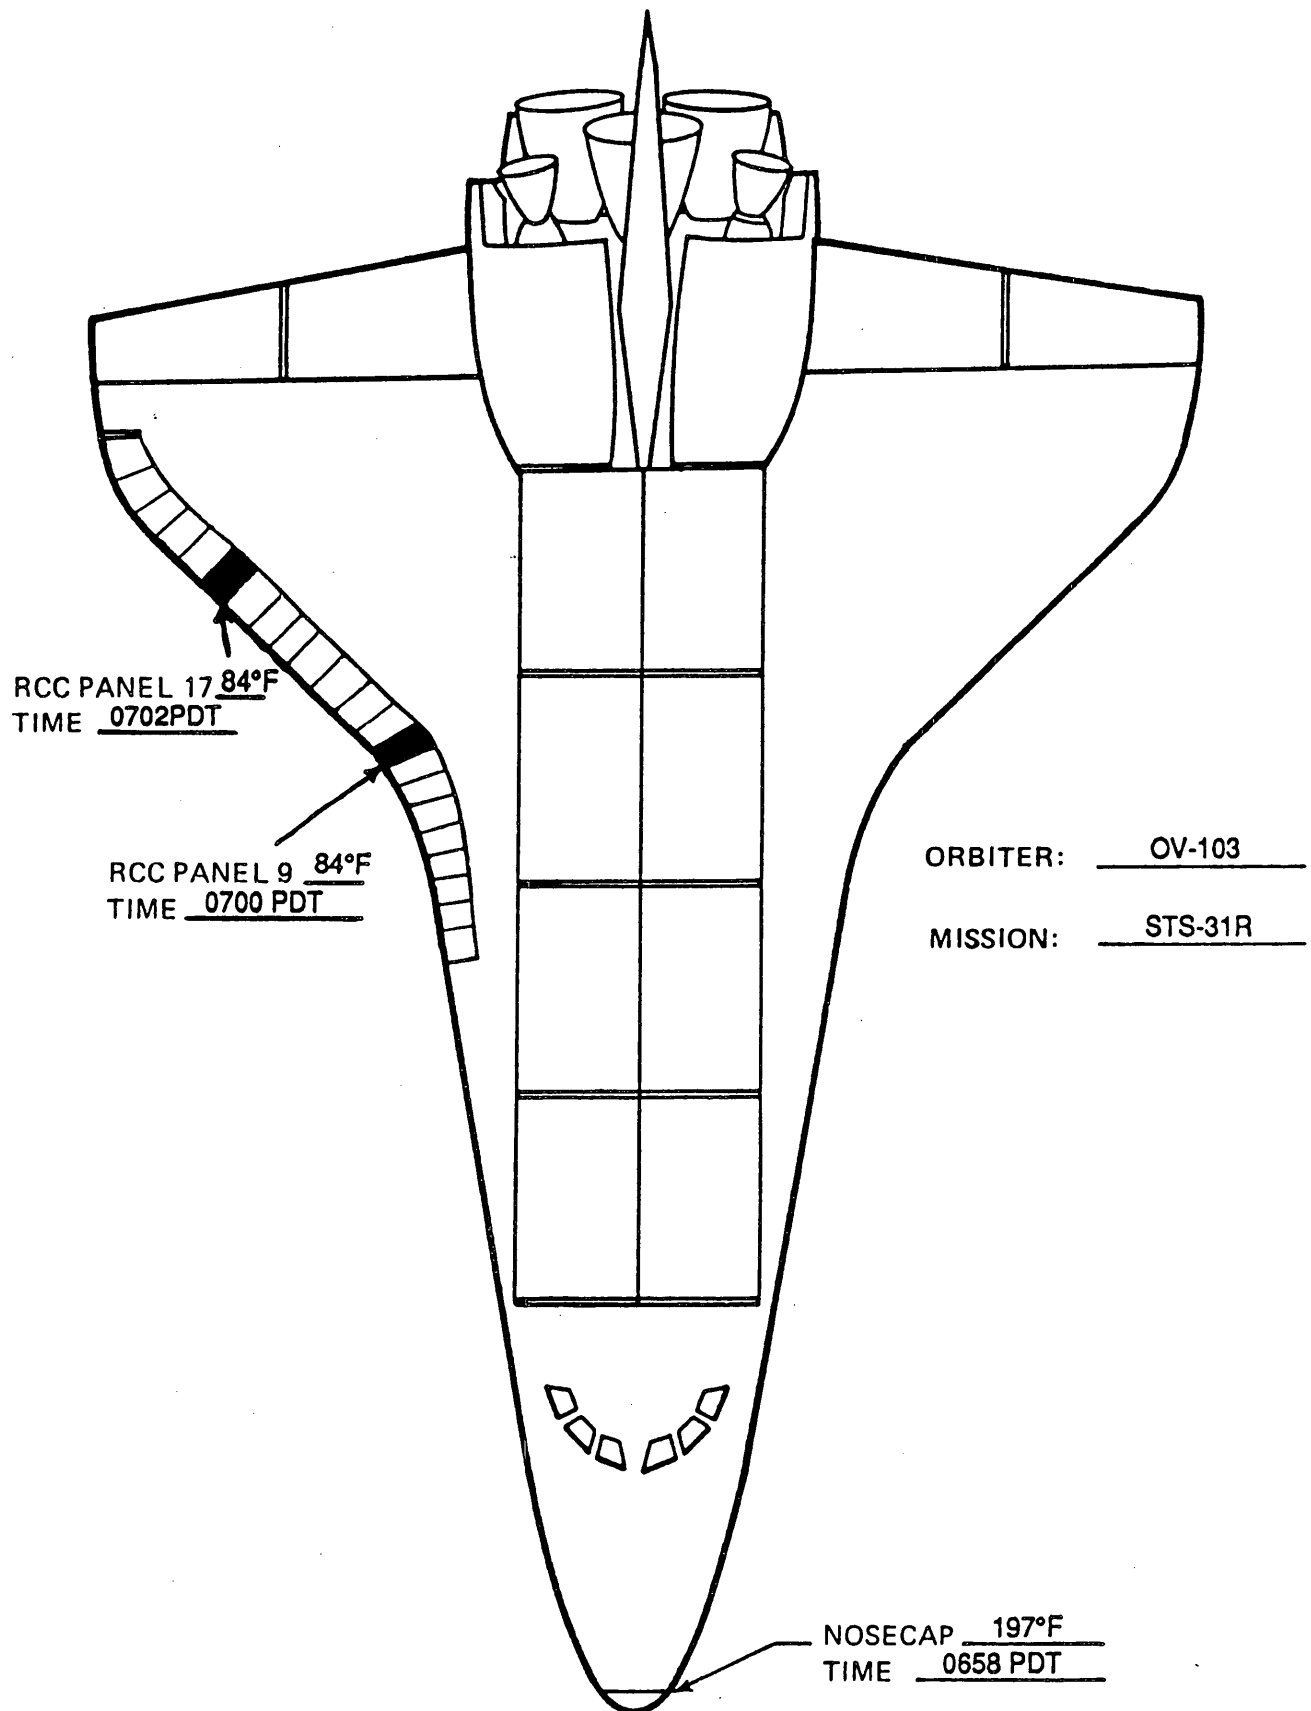
FIGURE 23. TEMPERATURE MEASUREMENTS

The KSC Shuttle Thermal Imager (STI) was used to record the kinetic surface temperatures of several areas (Figure 23). Nine minutes after landing the nose cap RCC measured 197 degrees F. Twelve minutes after landing the RH wing RCC panels #9 and #17 both measured 84 degrees F.

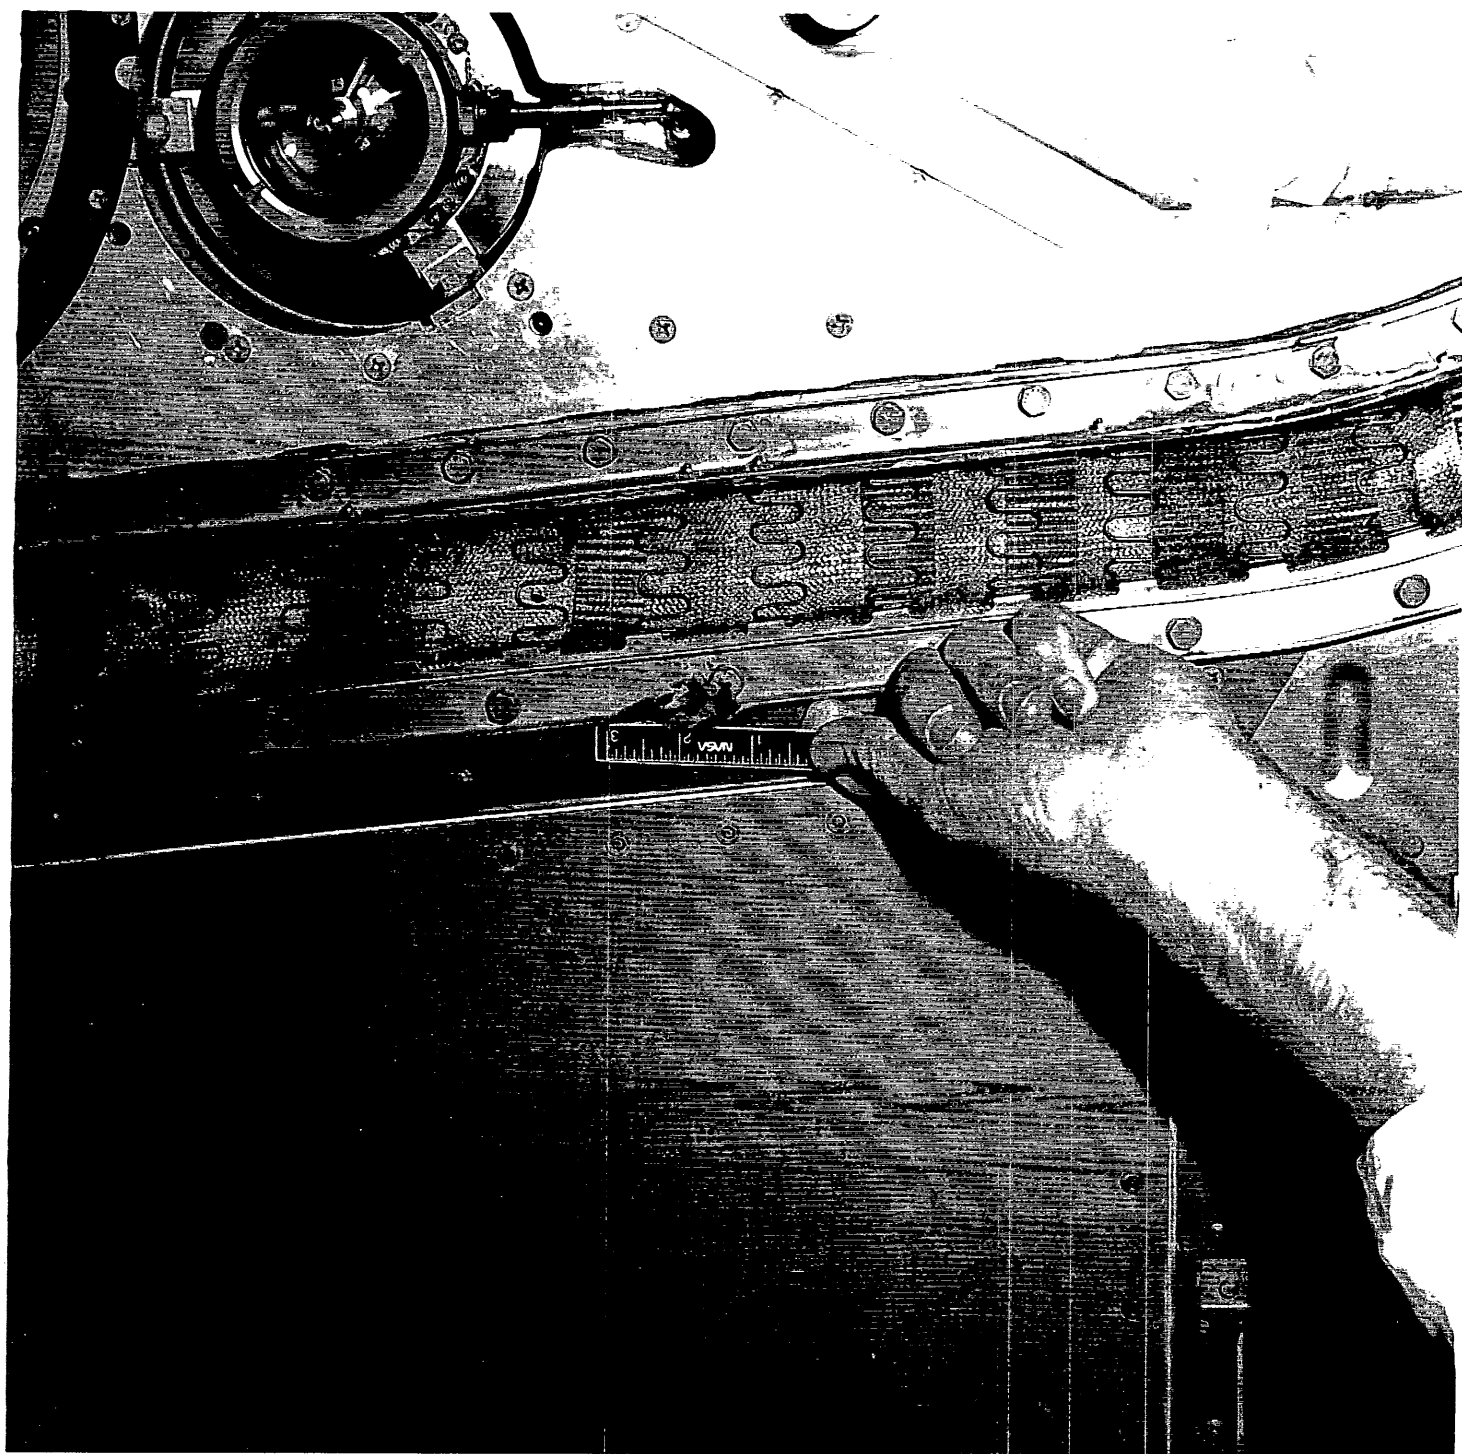
Two pieces of material were removed from the LH2 ET/Orbiter umbilical area shortly after landing. They were submitted to the KSC Microchemical Analysis Lab.

Brown/black-colored foreign material was removed from the LH2
ET/ORB umbilical for laboratory analysis

Brown/black-colored material removed from the LH2 umbilical
was closeout materials (foam and Viton rubber seal)

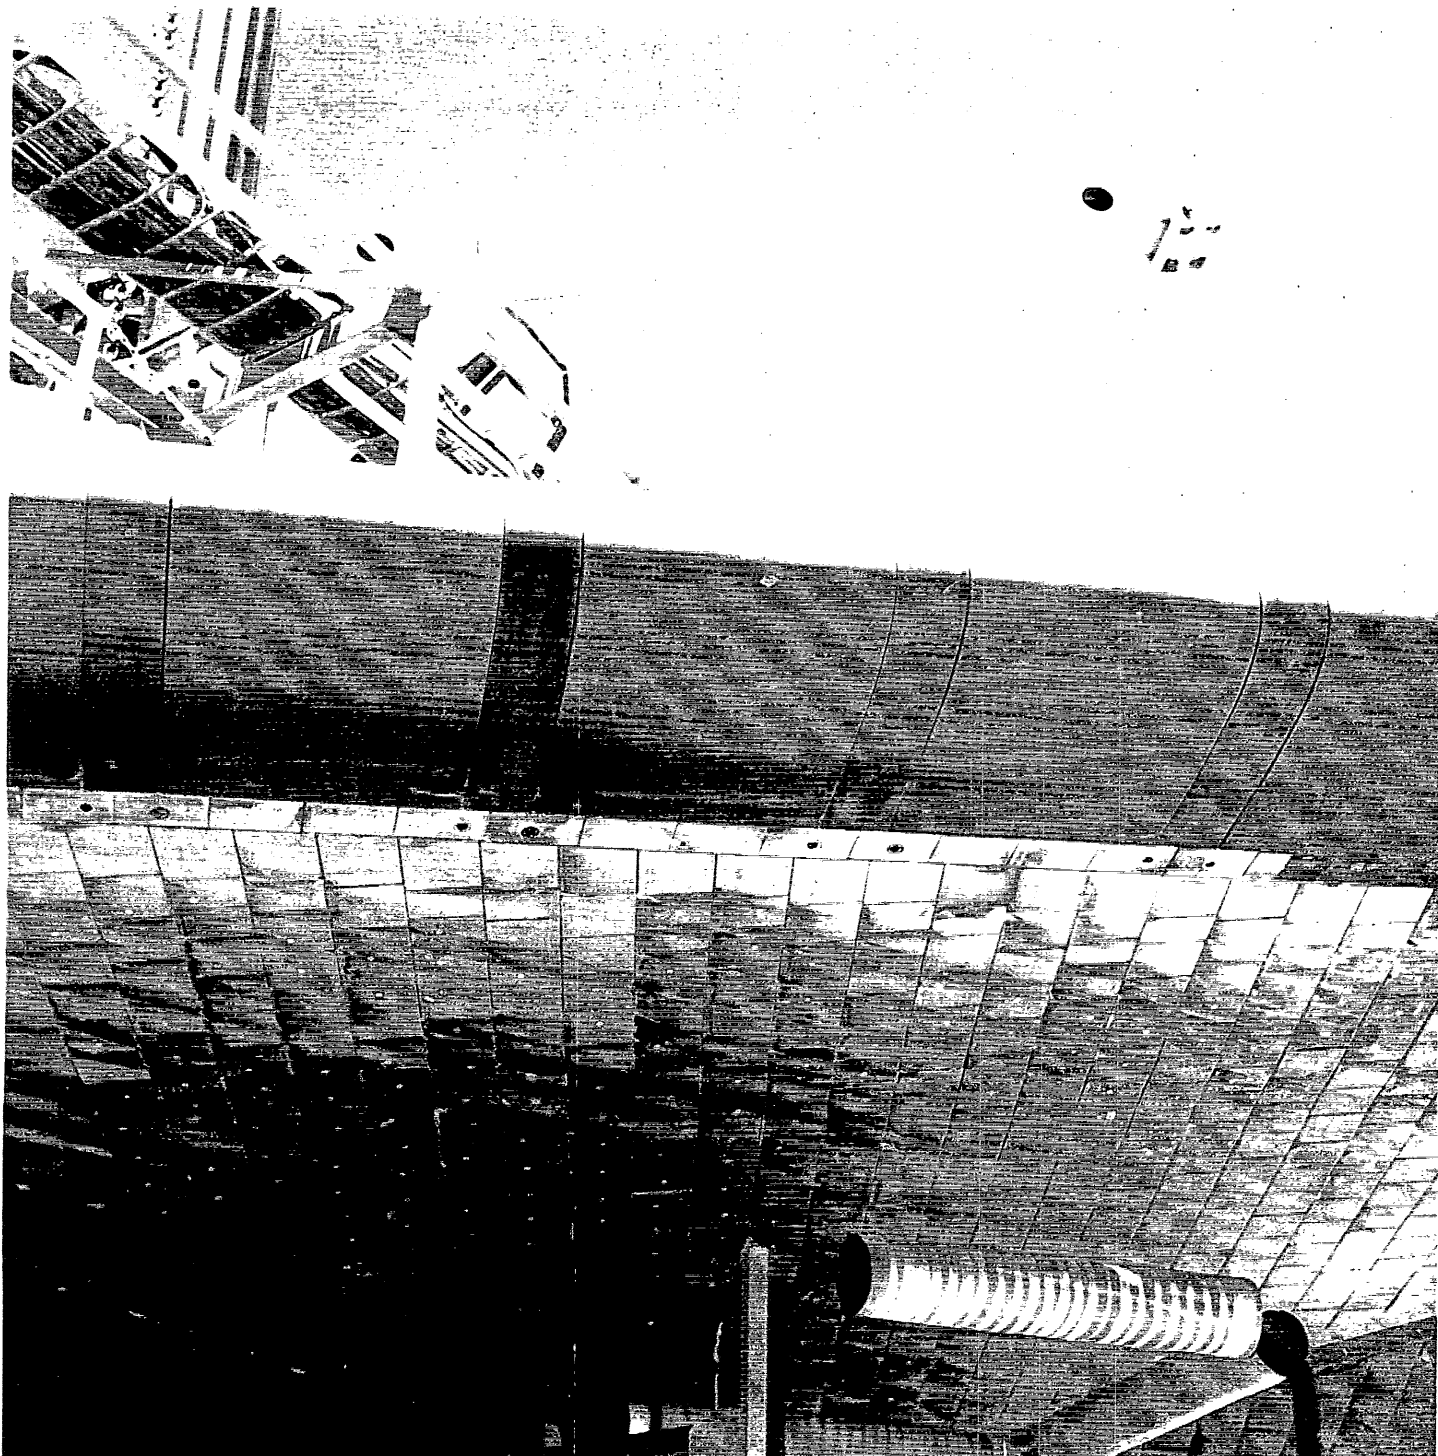
Analysis of light colored particle in the LH2 ET/ORB
umbilical revealed TPS closeout material

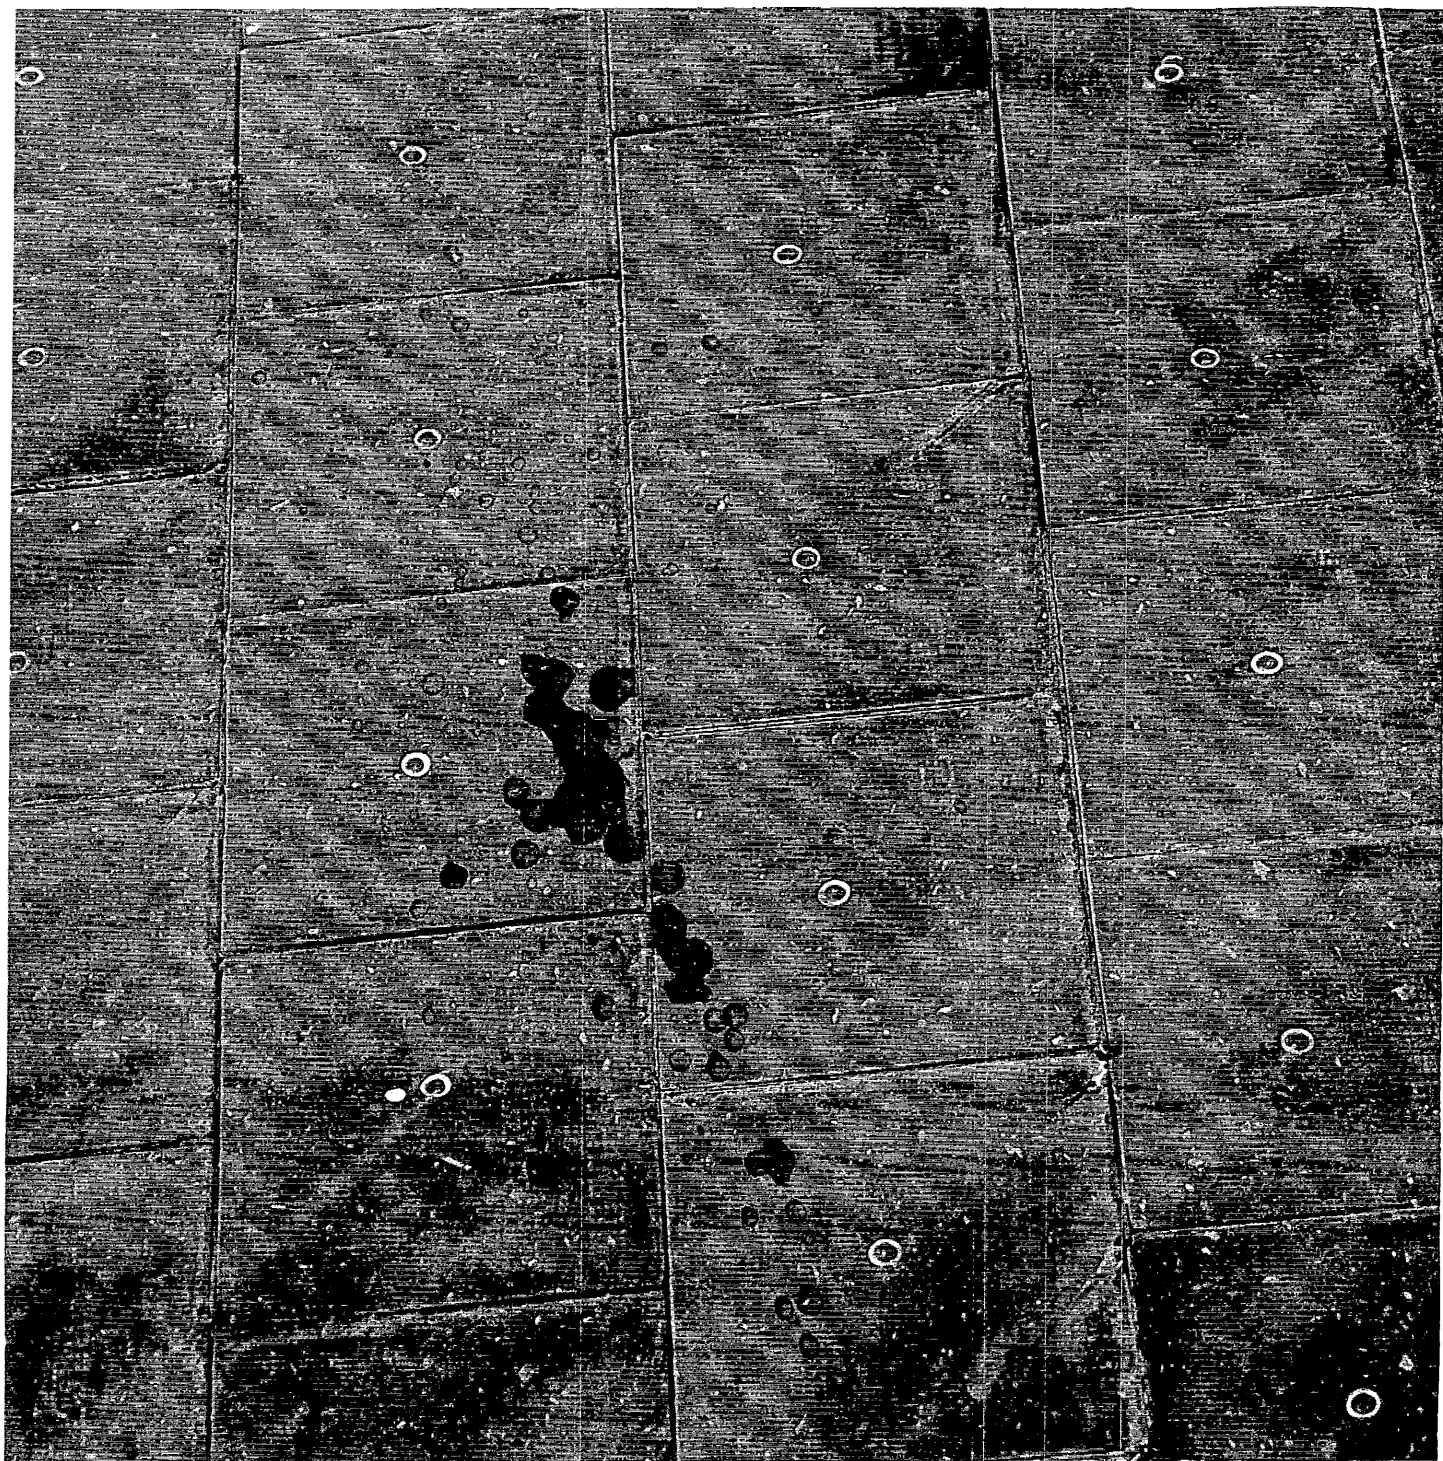
White residue on wing leading edge RCC panels was paint, TPS materials, BSM exhaust residue, and landing site products
